**WEDGEWIRE SCREEN SITE-SPECIFIC STUDY
ENGINEERING EVALUATION**

**GSP SCHILLER LLC – SCHILLER STATION
PORTSMOUTH, NEW HAMPSHIRE**

Submitted by:
Enercon Services, Inc.
7677 Oakport Street, #950
Oakland, CA 94621
July 28, 2020

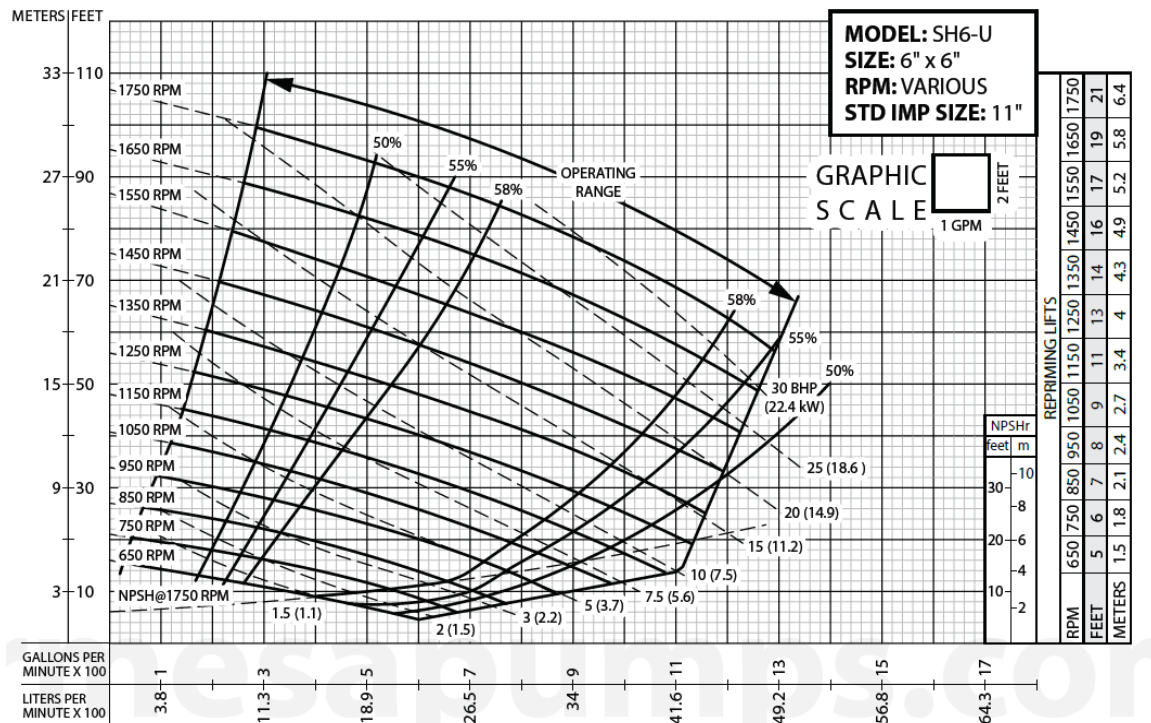
Figure 1: Barmesa SH6-U pump curve for an 11-inch impeller

According to the pump curve for the Barmesa SH6-U pump with an 11 in. impeller, the Net Positive Suction Head required (NPSHr) at flow rates of 361 gallons per minute (gpm) for 3.0 mm screens and 201 gpm for 0.8 mm screens at the highest motor speed is approximately 8.5 feet of water column (ft-H₂O) and 7.5 ft-H₂O, respectively, as seen in Figure 1. This corresponds to the pump suction pressure readings of approximately 3.7 psia and 3.2 psia, respectively. These

pressures correspond to readings of approximately 11.0 psig vacuum and 11.5 psig vacuum, respectively.

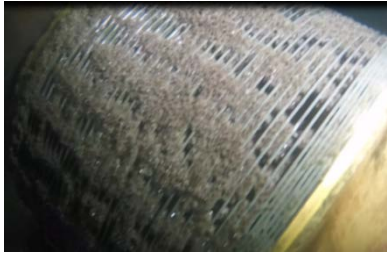
Upstream Riverside

This addendum was generated following a series of underwater inspections that documented the conditions of the pilot wedgewire screens after seven months of continuous operation. This addendum details the amount of screen fouling and damage observed during the underwater inspections from October 1, 2019. The impacts of the observed conditions were estimated based on the imagery captured during the underwater inspection. Further, the efficiency of the backflushing procedure was determined based on the comparison of imagery captured before, during and following the backflushing of the pilot wedgewire screens.
